Ion Beam Projects to Address 2017 Walkdown – Assessment of Ion Beam Facility Recommendations to Facilitate Transfer to EM Title:

Issued: 2021-05-20

Ion Beam Projects to Address 2017 Walkdown

Assessment of Ion Beam Facility Recommendations to Facilitate Transfer to EM

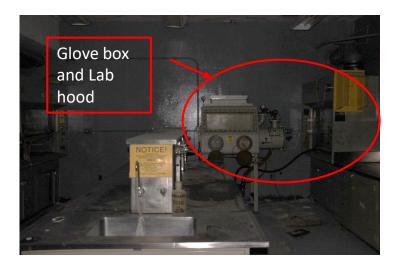
Basement Floor Laboratory Hood, Glove Box and Ducting Removal – Room 45

Before

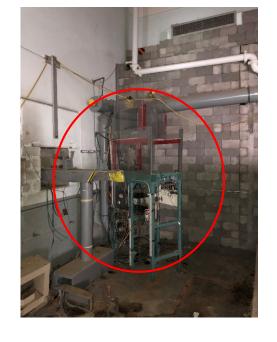
Basement Ducting Removal Adjacent to Horizontal Accelerator

Before
